## Case example and role of the Acumed Fibula Rod

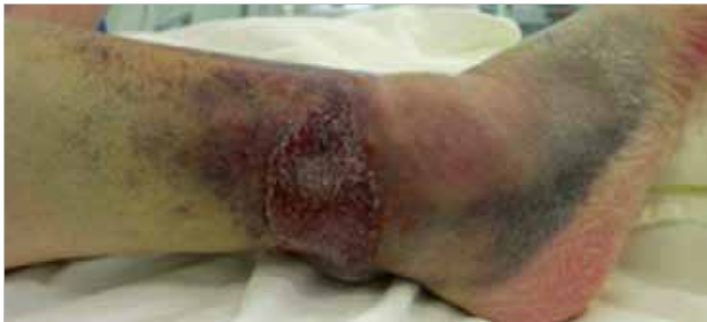
Intraoperative photo lateral

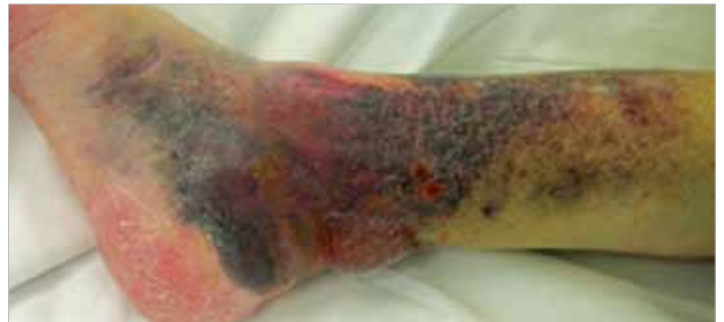
Intraoperative photo medial

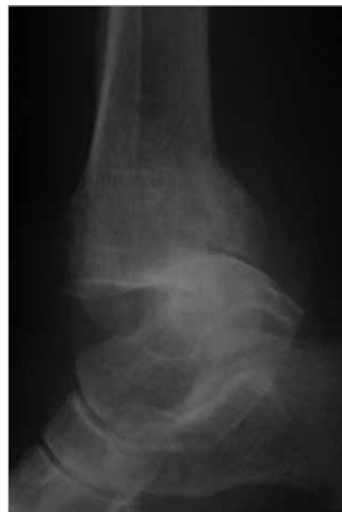
Pre-op x-ray M/L

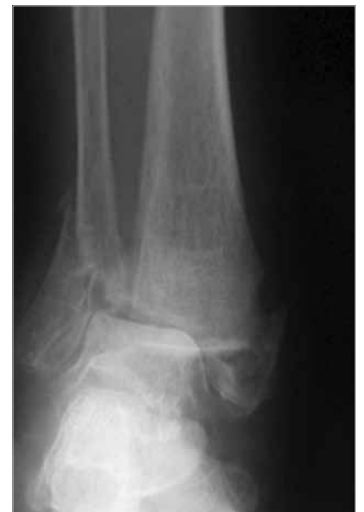
Pre-op x-ray A/P

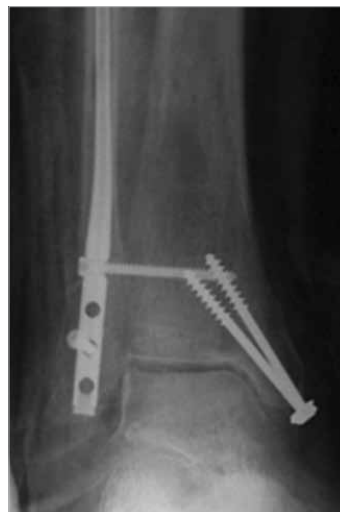
Post-op x-ray A/P

Surgeon decided to use Acumed's Fibula Rod System due to swelling and blistering. Open reduction of the lateral malleolus could have resulted in wound complications. The medial side was also fixed using a minimally invasive approach (two lag screws).
